Order No.: DD+DIS082.01E

**ADC Solo**

**Path Speed CR SP1001**

## **Error Message 247a7 (247AA from SOL\_1213 on) “IP-jam in scanner“ occurs frequently**

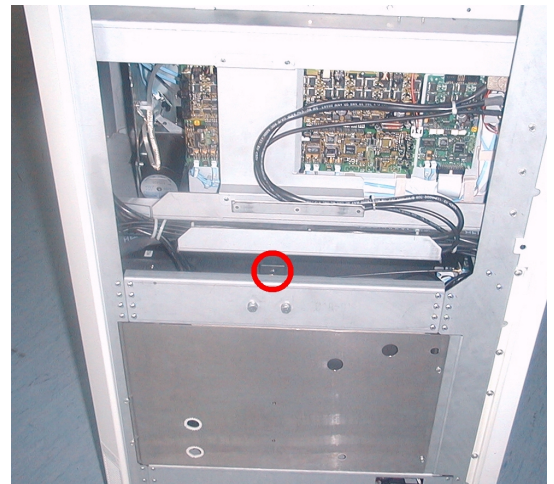
Defect: The scanner is adjusted wrongly, because the clamping elements in general have changed their geometric or material property.

Figure 1  
View from left side with upper scan  
fastening (circle)

- (1) Prepare a 15 x 30 cm resp.  
18 x 24 cm Cassette with an IP  
inside
- (2) Remove both side panels and  
bridge the interlock switch with  
the service key
- (3) Switch on the digitizer
- (4) Mark with a permanent marker  
or a scribe the fastening nut  
and the fastening plate at the  
front of the left side of the  
digitizer. The mark makes it  
easy to count the turns of the  
nut.

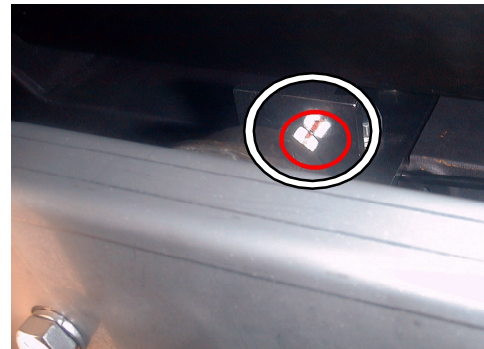
Figure 2  
Marked nut position

- (5) Turn the marked nut with an open-end wrench (13 mm) one complete turn counterclockwise. The scanner tilts to the left side, view at the input slot.

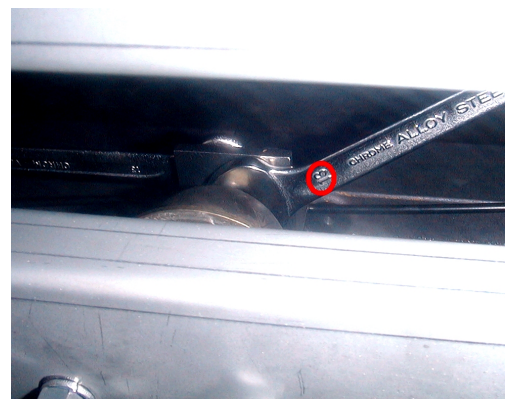
Figure 3  
Open-end wrench (13 mm)

- (6) Retighten the nut behind the fastening plate, mounted on the thread of the clamber.
